APPLICATION STORY

Quality assurance: FLIR Systems A-Series infrared cameras optimize motor vehicle dashboard production

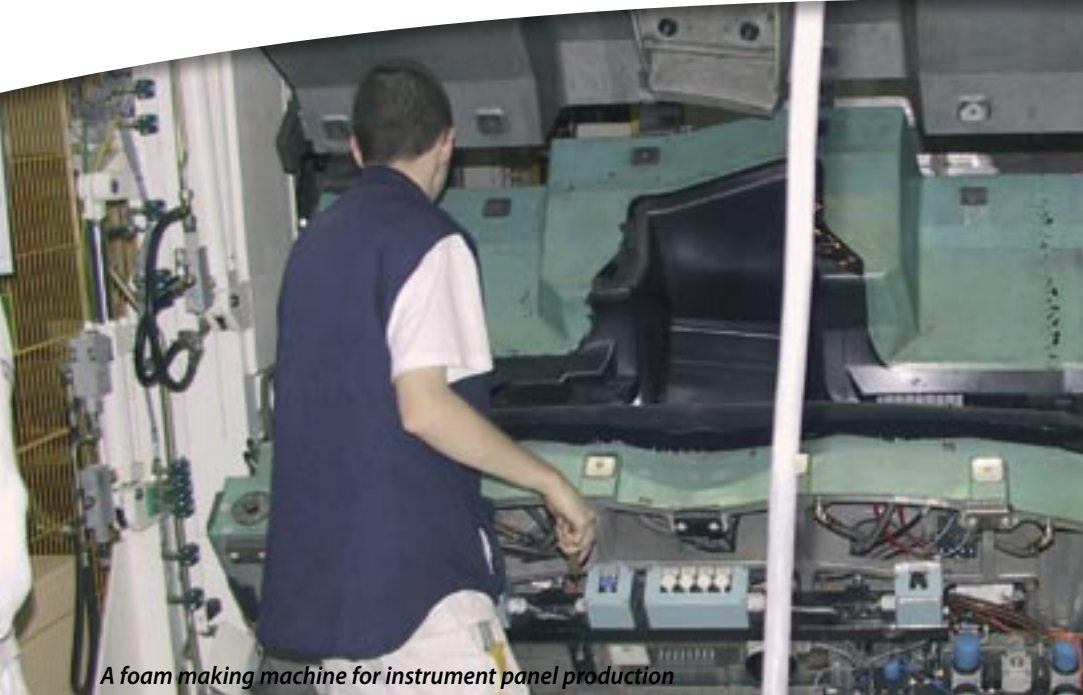
A foam making machine for instrument panel production

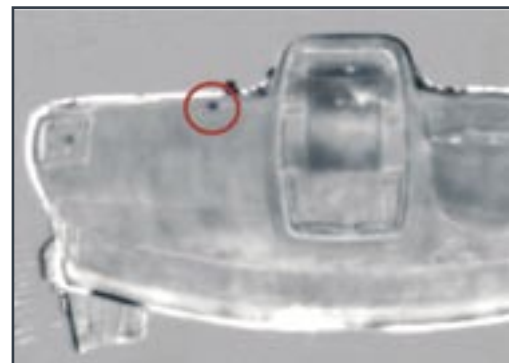
Result image showing cavities in the foam

The measurement solution DashboardCheck™ developed by German system integrator Automation Technologies works with image processing technology that is based on the difference in cooling cycles of the defective and error-free areas. The solution also gathers and stores data and evidence for further process optimization and quality assurance.
